# TRUCK SERVICE BULLETIN

NO. T-8-201

Subject: VALVE ROCKER ARM SHAFT AND BRACKET ASSEMBLY

Models: 228, 236, 248 AND 270 ENGINES

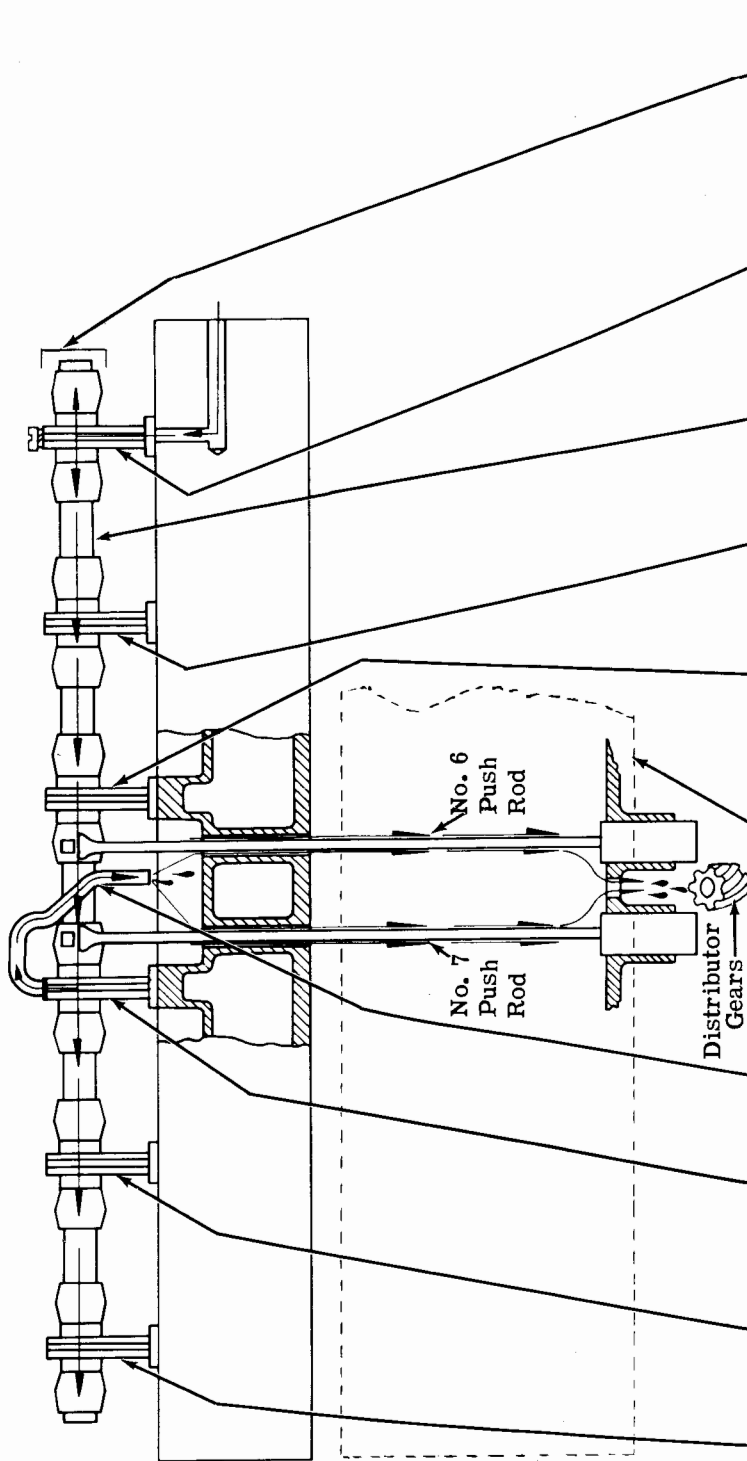
Figure 2 - Diagram Showing Current Method of Lubricating Distributor Gear, with Possible Parts Combinations.

Beginning with 1950 vehicles, subject engines current in production have the overflow tube attached to the No. 4 valve rocker arm shaft bracket. A new rocker arm shaft is used having an oil outlet hole located to correspond with the number four bracket position. Overflow oil from the tube now passes down along the No. 6 and 7 push rods and through the hole in the block to the distributor gears. Refer to Figure 2.

In addition to the new rocker arm shaft, the latest arrangements includes new overflow tube, new No. 2, 3, 5 and 6 rocker arm shaft brackets and the use of the former No. 6 rocker arm shaft bracket in the number 4 position. A new push rod cover which does not incorporate a collector trough is used.

| Description | No. 6 Bracket | No. 5 Bracket | No. 4 Bracket | Overflow Tube | Push Rod Cover | No. 3 Bracket | No. 2 Bracket | Shaft and Plug Assembly | No. 1 Bracket | Rocker Arm Shaft and Bracket Assembly |
|---|---|---|---|---|---|---|---|---|---|---|
| Possible combinations of old and new parts when overflow tube is at No. 4 Bracket | 2193783<br>or<br>2136568<br>Plugged with set screw<br>6107396<br>& washer<br>120382 | 2193783<br>or<br>2136567 | 2136568 | 2193775 | 6107439<br>(228, 236, 248 Engines)<br>2135424<br>(270 Engine)<br>or<br>Old cover with oil tube removed and discarded as shown in Figure 3. | 2193783<br>or<br>2136567 | 2193783<br>or<br>2136567 | 2193773 | 2136568 | |

Otherwise various combinations of old and new parts may be used until old stock is exhausted, depending upon the location of the overflow tube, as shown in Figures 1 and 2.

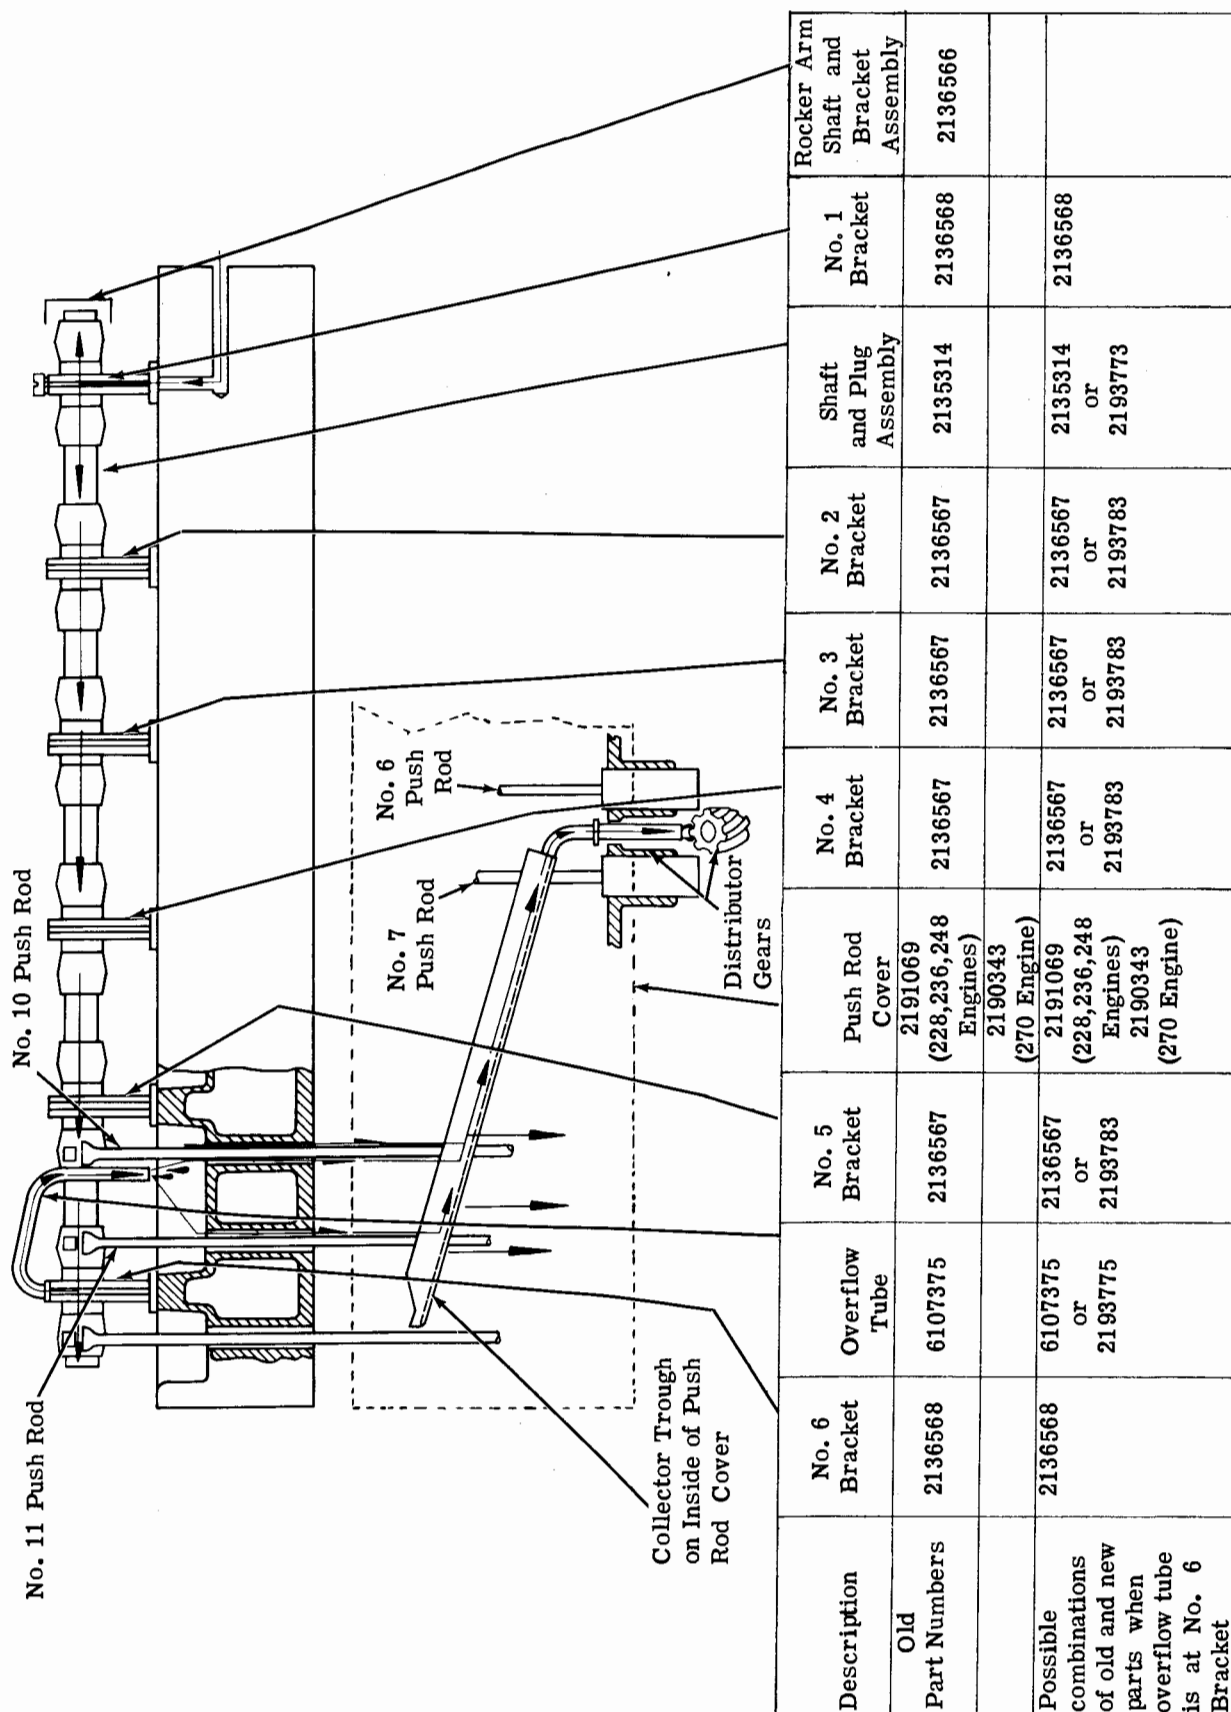
Figure 1 - Diagram Showing Old Method of Lubricating Distributor Gears, with Possible Parts Combinations.

In subject engines prior to 1950, excess oil from the valve rocker arm shaft passes through an overflow tube which is attached to the rear (No. 6) valve rocker arm shaft bracket.

Oil then flows down by the No. 10 and 11 push rods and is collected in a trough attached to the inside of the push rod cover. A tube on the end of the trough directs the oil down a hole drilled in the block between No. 6 and 7 push rods, directly above the distributor drive gears as shown in Figure 1.

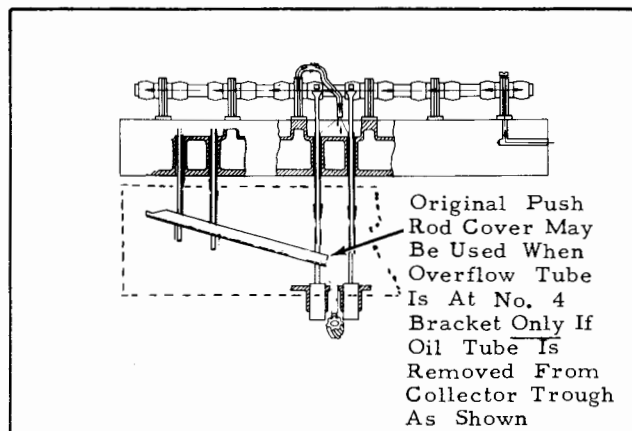
Figure 3 - View Showing Collector Trough Reworked By Removal of Oil Tube

e. The latest push rod cover does not include an oil collector trough.

The new rocker arm, shaft and bracket assembly may be used to replace the original assembly by also using new overflow tube and either using new push rod cover, or reworking old cover as shown in Figure 3.
